Kontroll av AWECO trevägsventil

Checking the AWECO three-way valve

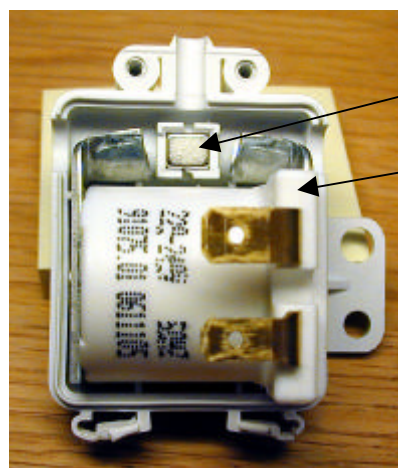
Ventilen i genomskärning
Valve cut away

1. The coil should have a resistance of 2,8 kOhm. If the coil is defective it can be changed by undoing the two screws and open the front of the valve body. Make sure that the two small permanent magnets are in position before closing the front again.
2. If the coil is in order the valve can be checked as follows:
 - Make sure that the product is without current by unplugging the connection cord.
 - Dismount the control panel and disconnect the contact for the sensors.
 - Plug in the connection cord again. Within ten seconds one or two clicks should be heard from the valve.

Magnet

Spole / Coil

1. Spolen skall ha en resistans på 2,8 kOhm. Om spolen är felaktig kan den bytas genom att lossa de två skruvarna och öppna fronten på ventilhuset. Se till att de två små permanentmagneterna ligger på plats innan fronten stängs igen.
2. Om spolen är hel kan funktionen av ventilen kontrolleras enligt följande:
 - Gör produkten strömlös genom att dra ur anslutningsladden.
 - Demontera kontrollpanelen och koppla loss kontakten till temperatursensorerna.
 - Sätt i anslutningsladden igen. Inom tio sekunder skall ett eller två klick höras från ventilen.
